LAYCOCK, Elizabeth and WOOD, Christopher (2014). Understanding and controlling the ingress of driven rain through exposed, solid wall masonry structures. Geological Society special publication, 391, 175-191.

# **Understanding and controlling the ingress of driven rain through exposed, solid wall masonry structures**

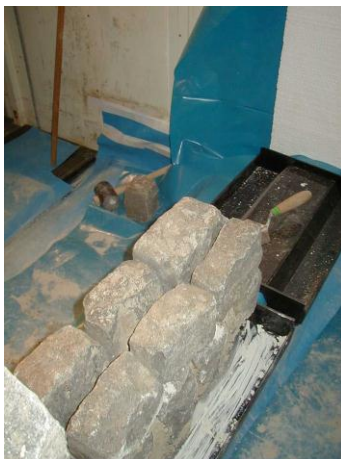
Temperature sensors (copper constantan type-t thermocouples) proprietary humidity sensors and trial water sensors were implanted during the build, and the resulting wallettes were isolated from each other by polystyrene and silicone sealant. The test panels were also sealed to top of the chamber using a false wall to prevent water ingress from above. See Figure 3

**Figure 2** *Walls for pilot work under construction. Photograph from rear face*

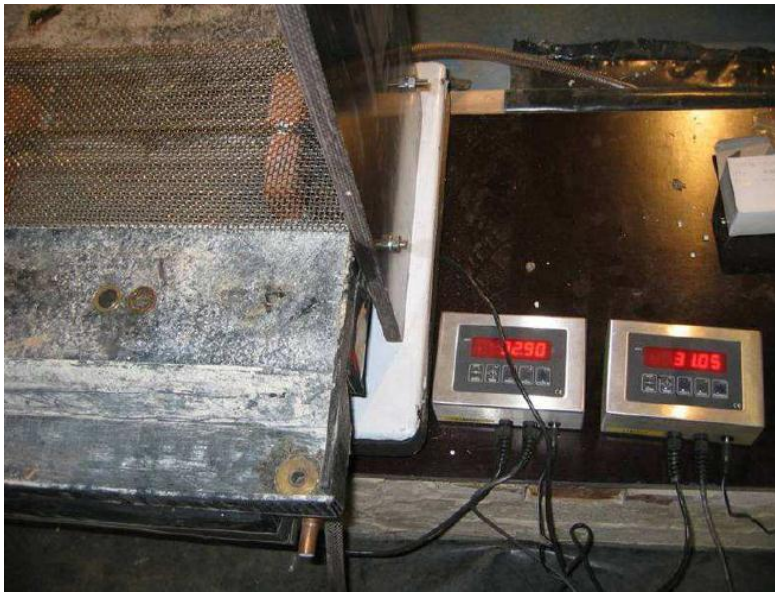
**Figure 5** The weighing balance used in the continuation work showing the base with heavy duty gauze so that water discharging through the core can be collected in the trough. (Photograph from Wood, 2010)

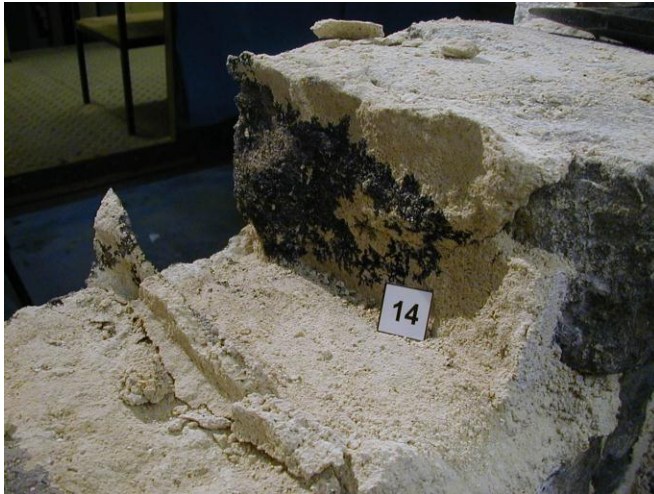
Before demolition wall 5 was exposed to water soluble paint with pressurised conditions to expose the routes taken by water flowing through the wall. Penetration was seen to be concentrated around the mortar at the front faces, as would be expected, and many of these failed to reach to any depth. There were a number of pathways along the perpend joints, a typical example is shown in Figure 12. Pathways were complex at the transition point between the front and rear skins of the wall, with water tracking behind the back of the blocks while the bed face beneath remained dry. In some cases this water managed to migrate on the same course to the rear of the wall, in others the water made no further lateral progress than to the central area of mortar but descended downwards through the wall core. Dye penetration through this wall could be visually seen as most commonly associated with blocks which ran from the front to the back of the wall which were also associated with the points of air leakage identified prior to testing. However water penetration was not consistently related to high air penetration although there were some areas where internal voids appeared to be allowing conduction of significant quantities of water.

**Figure 12** Dye penetration test on Wall 5 after first pilot work.

Before demolition wall 5 was exposed to water soluble paint with pressurised conditions to expose the routes taken by water flowing through the wall. Penetration was seen to be concentrated around the mortar at the front faces, as would be expected, and many of these failed to reach to any depth. There were a number of pathways along the perpend joints, a typical example is shown in Figure 12. Pathways were complex at the transition point between the front and rear skins of the wall, with water tracking behind the back of the blocks while the bed face beneath remained dry. In some cases this water managed to migrate on the same course to the rear of the wall, in others the water made no further lateral progress than to the central area of mortar but descended downwards through the
